PROPERTY INSPECTION REPORT

Concerning: Your Address

By: Jason Ettredge

1/27/2023

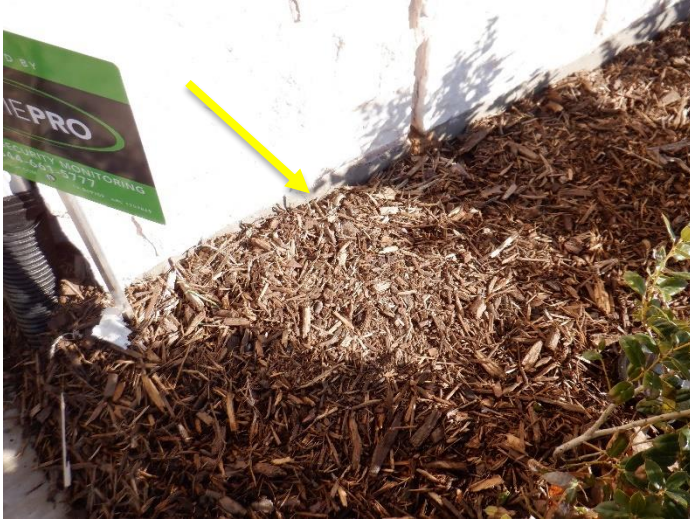
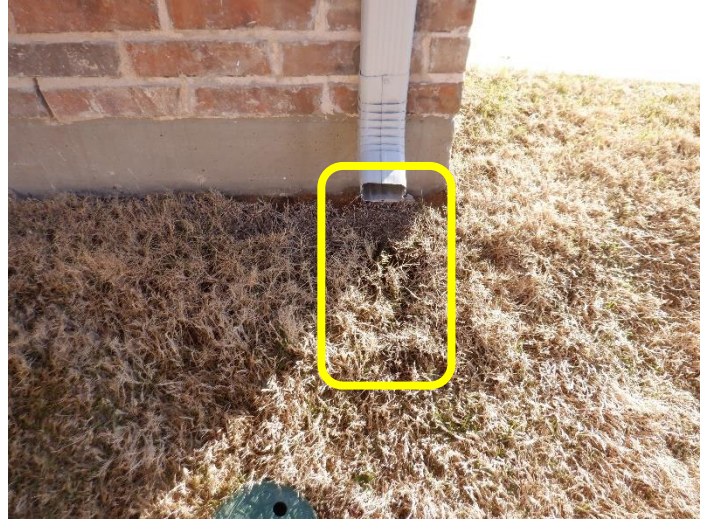
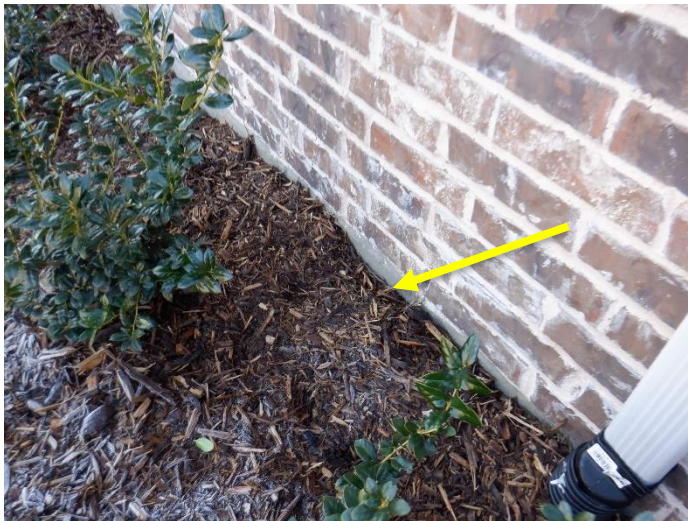
B. Grading and Drainage**Drainage Condition:** Satisfactory**Comments:**

- High soil noted in several areas. Soil level should be 6 inches from top of foundation.
- All downspouts should be equipped with splash blocks to prevent erosion.

-
- High soil noted in several areas. Soil level should be 6 inches from top of foundation.
- All downspouts should be equipped with splash blocks to prevent erosion.

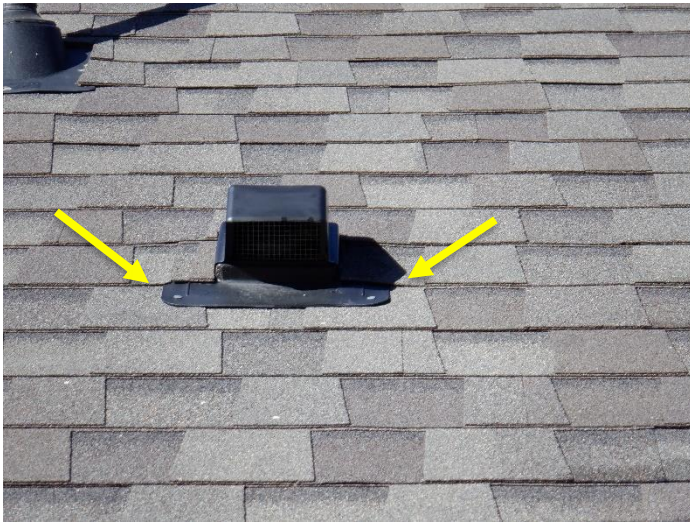
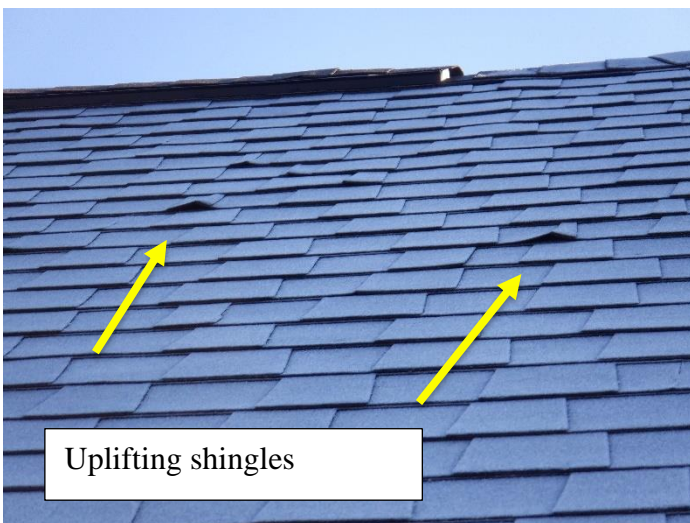
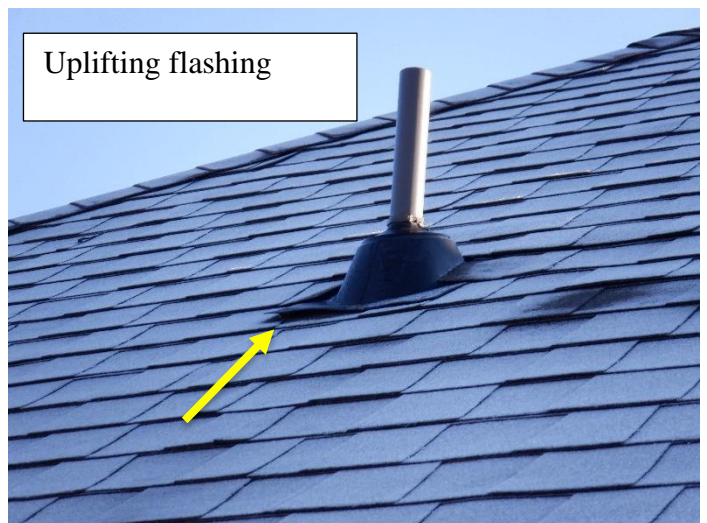
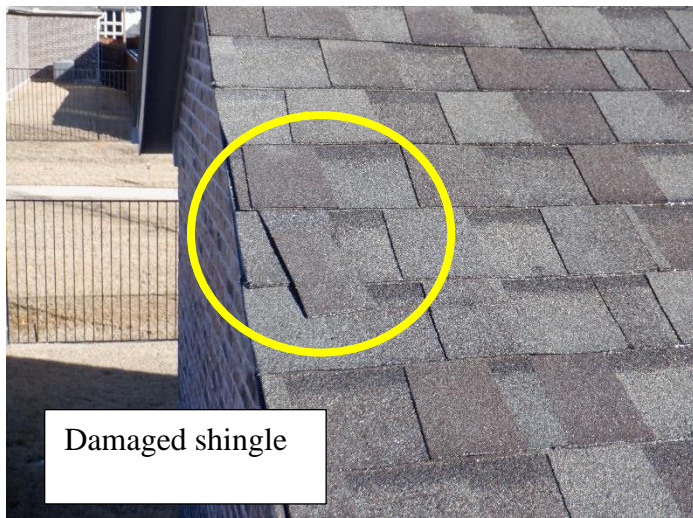
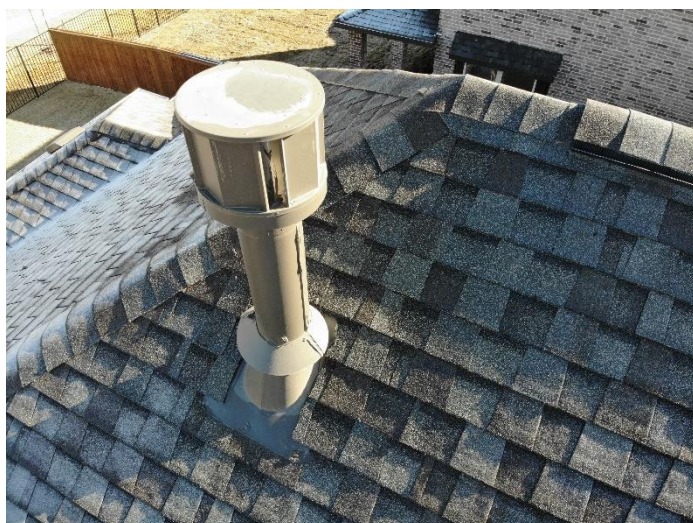
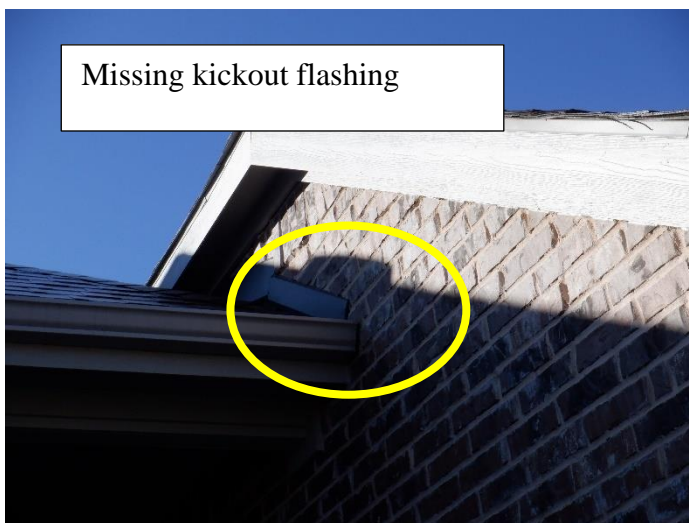
☒ ☐ ☐ ☒ **C. Roof Covering Materials**

- All exposed roof nails should be sealed with roofing cement or silicone sealant to prevent moisture intrusion.
- One or more gutter "kick out" flashings are missing.
- Shingles or flashing is uplifting in some areas.
- Some damaged or missing shingles were observed.
- I recommend a Certified Roofing Company evaluate and repair as required.

- All exposed roof nails should be sealed with roofing cement or silicone sealant to prevent moisture intrusion.
- One or more gutter "kick out" flashings are missing.
- Shingles or flashing is uplifting in some areas.
- Some damaged or missing shingles were observed.
- I recommend a Certified Roofing Company evaluate and repair as required.

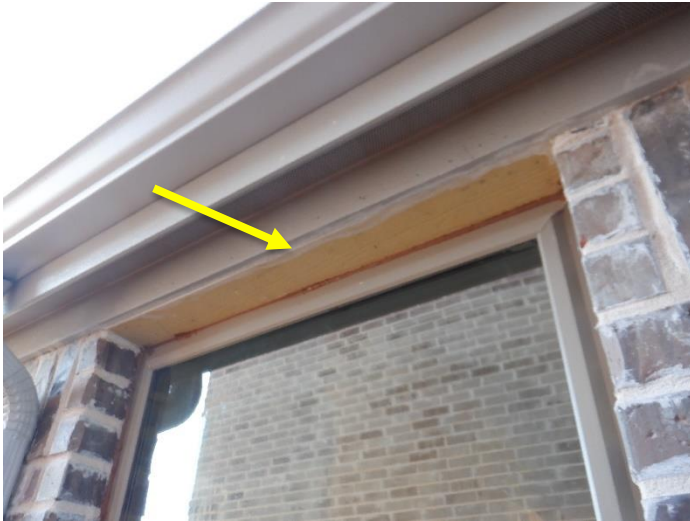
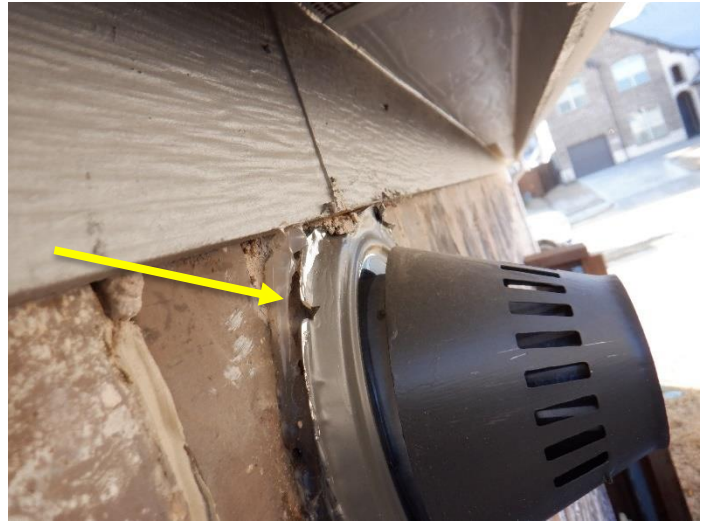
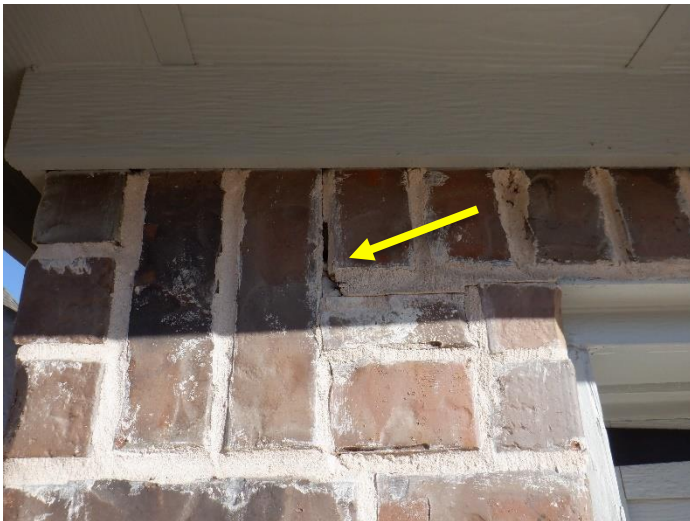
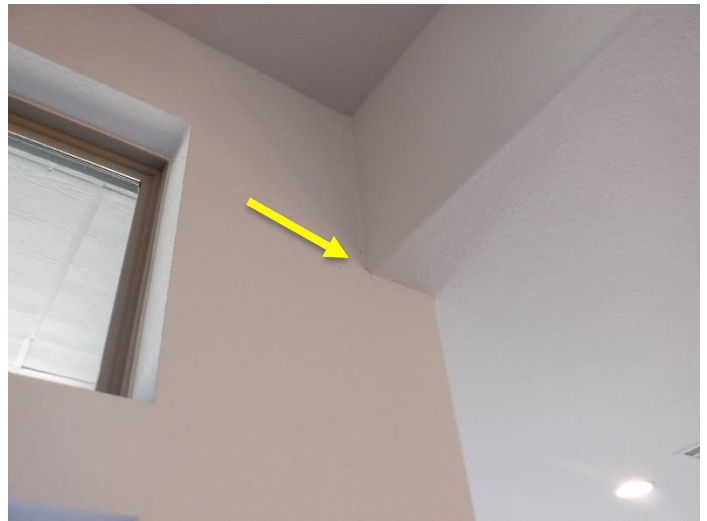
E. Walls (Interior and Exterior)

- Wall penetrations not properly flashed/sealed.
- Mortar is separated or missing in some areas.
- Exposed exterior wood should be painted or stained and sealed.

-
- Wall penetrations not properly flashed/sealed.
- Mortar is separated or missing in some areas.
- Exposed exterior wood should be painted or stained and sealed.

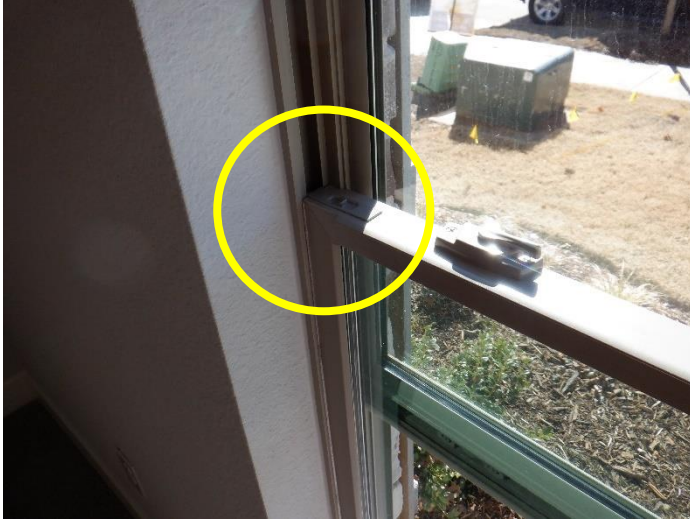
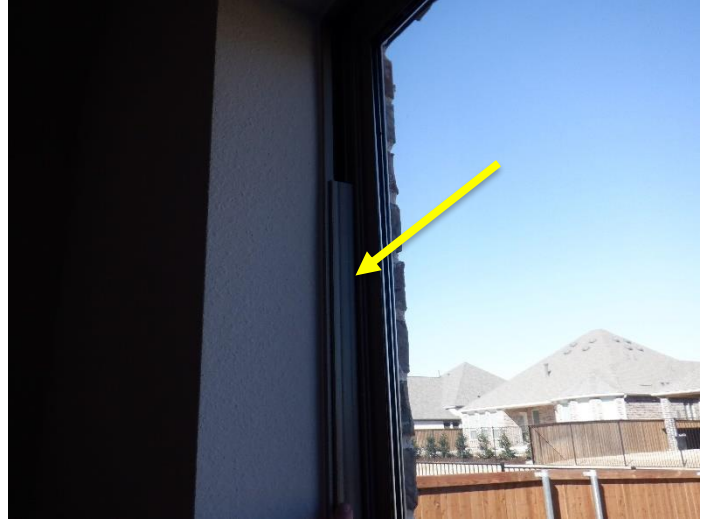
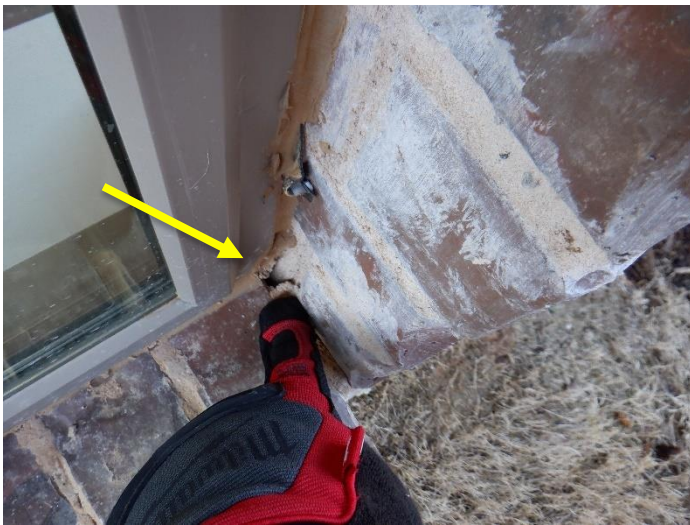
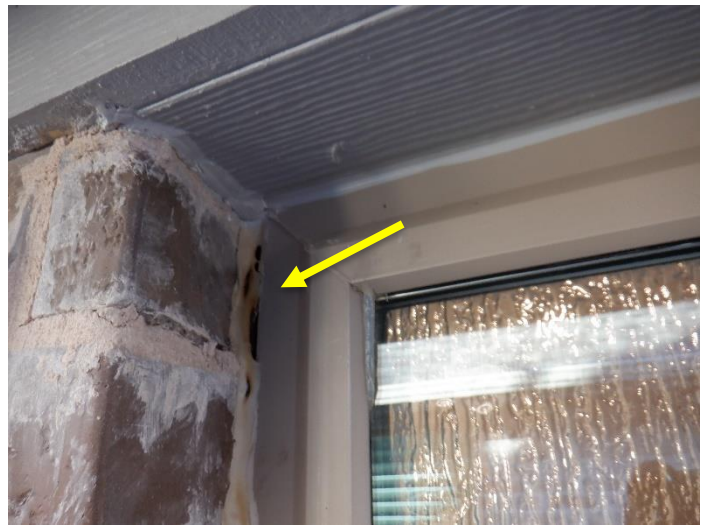
H. Windows

- Window screens not present.
- Windows need to be caulked or re-caulked.
- Some windows are not properly sealed.
- Some windows are difficult to open/close when opened inward.
- Some interior window trim is damaged and in need of repair or replacement.

-
- Window screens not present.
- Windows need to be caulked or re-caulked.
- Some windows are not properly sealed.
- Some windows are difficult to open/close when opened inward.
- Some interior window trim is damaged and in need of repair or replacement.

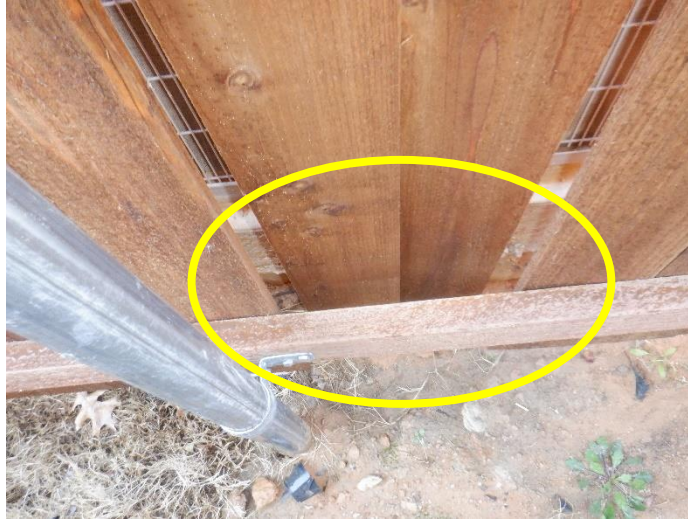
Fencing:

- Several fence pickets are loose/missing or damaged.

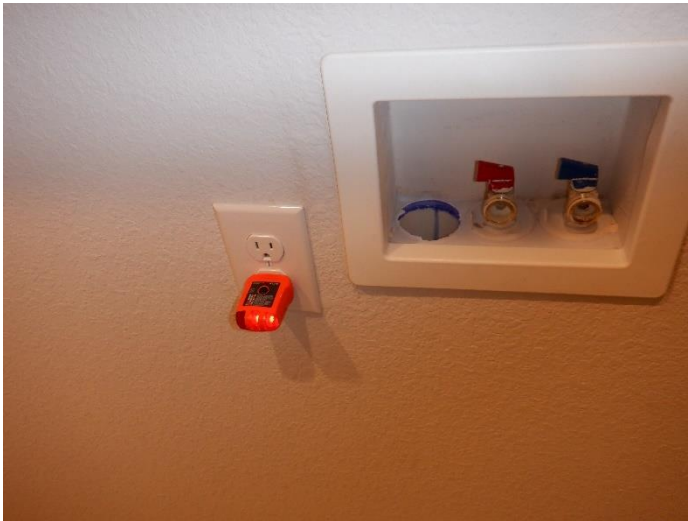
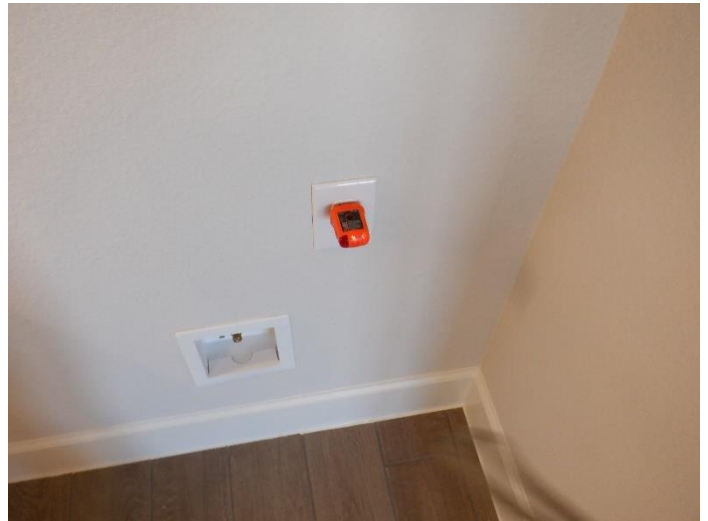
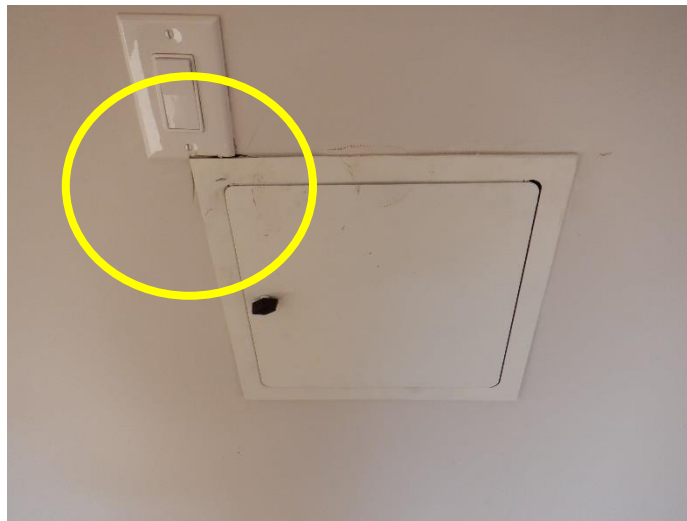
B. Branch Circuits, Connected Devices, and Fixtures

- One or more GFCI receptacles are not installed or defective. TREC recognizes this as a Safety Hazard and recommends this be corrected.
- Laundry room does not have GFCI Receptacles.
- Refrigerator does not have GFCI Receptacle.

- Loose/damaged/missing covers noted on several outlets.

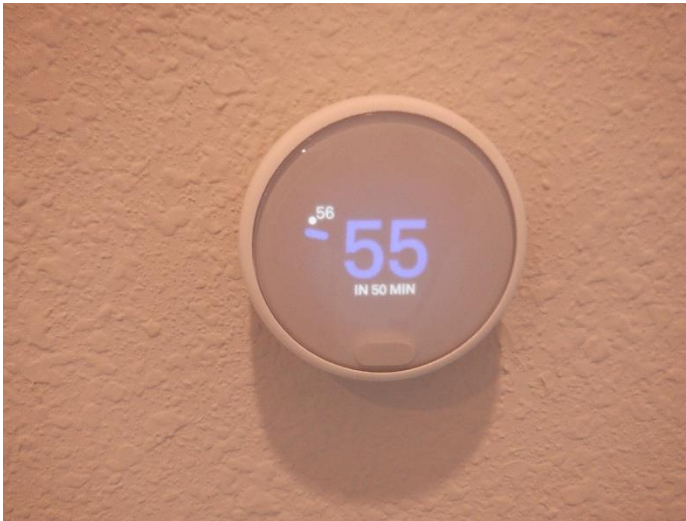
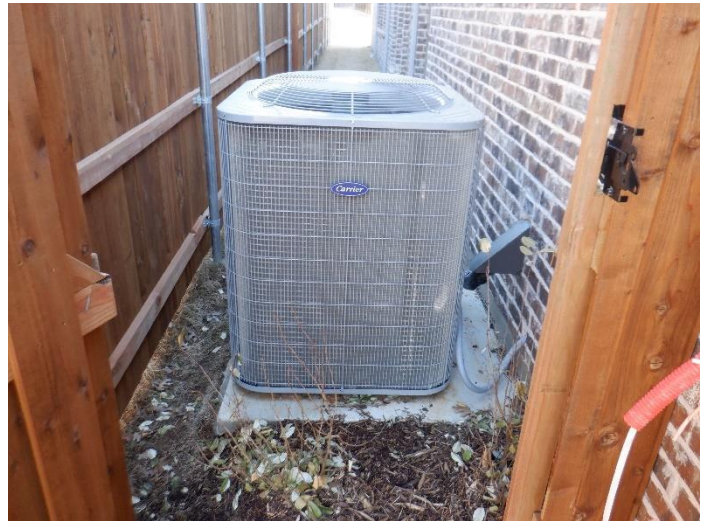
☐ ☒ ☐ ☒ **B. Cooling Equipment**

- Unable to operate air conditioner(s) in temperature below 60 degrees.
- Condenser coil fins damaged.
- When first entering property, I noted the thermostat was set in “cooling mode” to 55 degrees F and indoor temperatures was 57 degrees F. Unit appeared to have been running for an extended amount of time. Outdoor temperature was 32 degrees F. Exterior refrigent lines and compressor had frost build up.
- I recommend a Licensed HVAC technician evaluate to ensure no damaged to the unit occurred during this period.

-
- Unable to operate air conditioner(s) in temperature below 60 degrees.
- Condenser coil fins damaged.
- When first entering property, I noted the thermostat was set in “cooling mode” to 55 degrees F and indoor temperatures was 57 degrees F. Unit appeared to have been running for an extended amount of time. Outdoor temperature was 32 degrees F. Exterior refringent lines and compressor had frost build up.

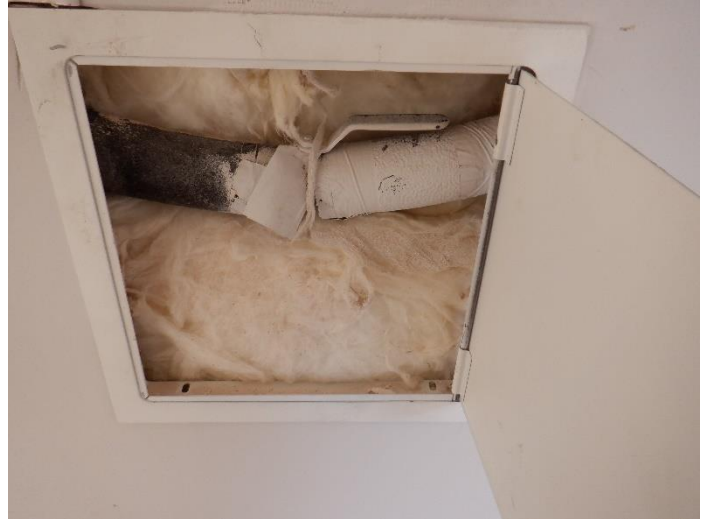
☒ ☐ ☐ ☒ A. Water Supply System and Fixtures

- Mixing valve is missing in master bathroom.

- Front bathroom shower head is leaking.

- Master bathroom commode does not flush correctly.

- Plumbing pipes in attic are not fully insulated.

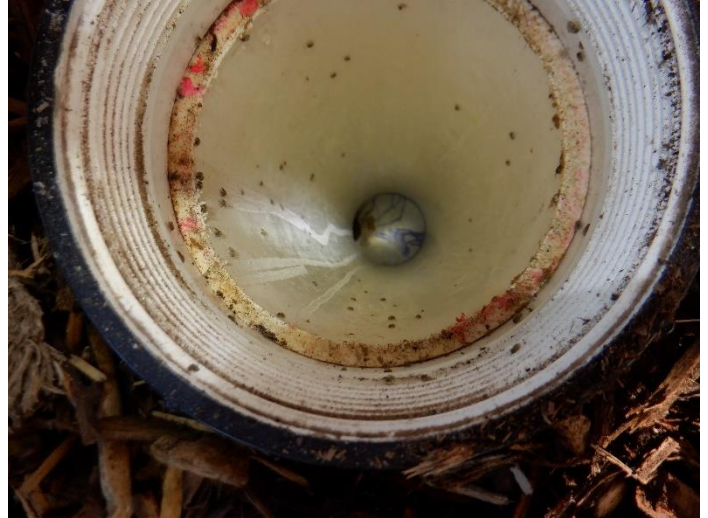
☒ ☐ ☐ ☒ **B. Drains, Wastes, and Vents**

- Front bathroom sink drain stop is inoperable.

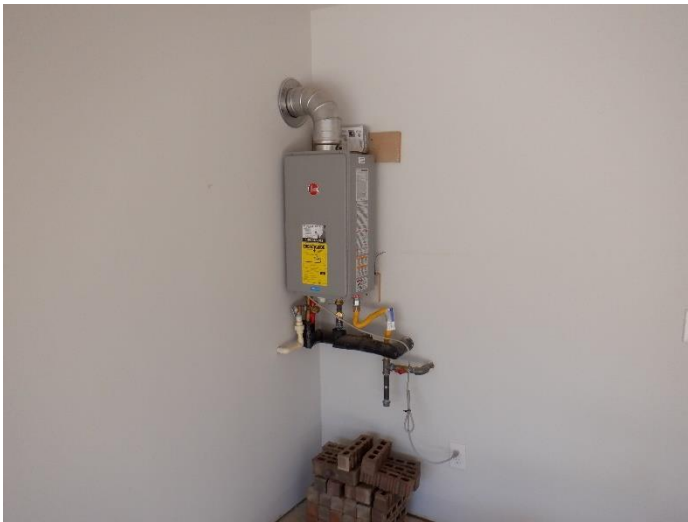
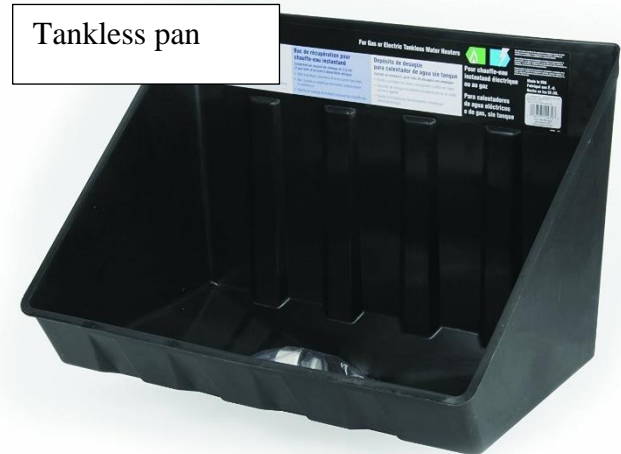
Tankless pan

- Unit has no drain pan and/or drain line installed under unit. Requirement for unit located in areas that a leak could cause damage.

- Unit has no drain pan and/or drain line installed under unit. Requirement for unit located in areas that a leak could cause damage.

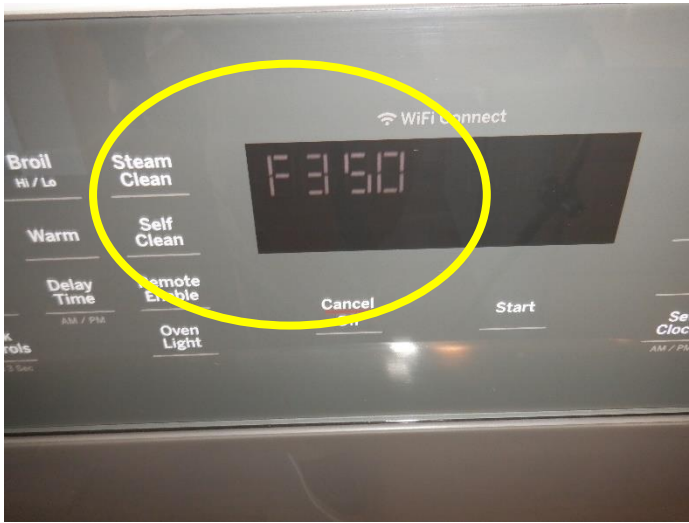
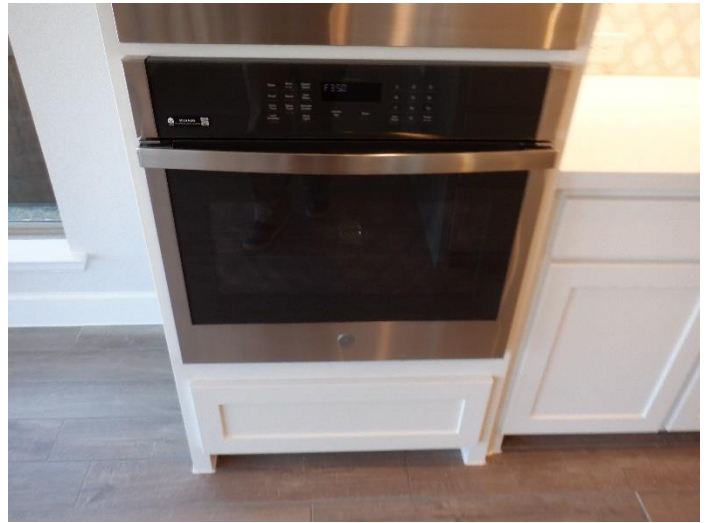
☒ ☐ ☐ ☒ D. Ranges, Cooktops, and Ovens

- Oven did not operate.

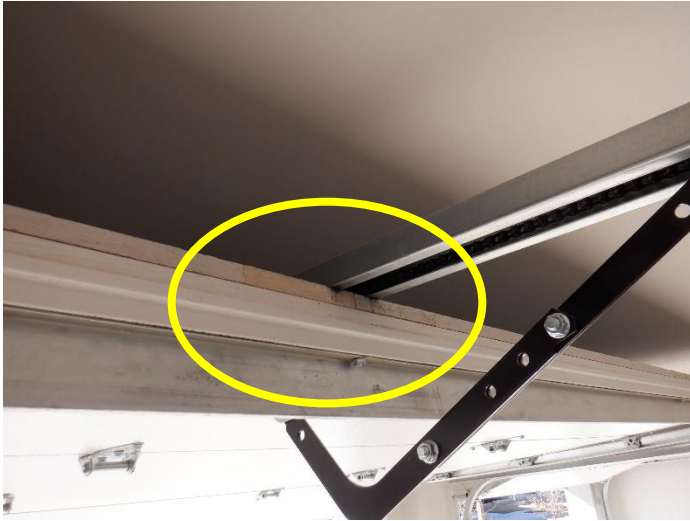
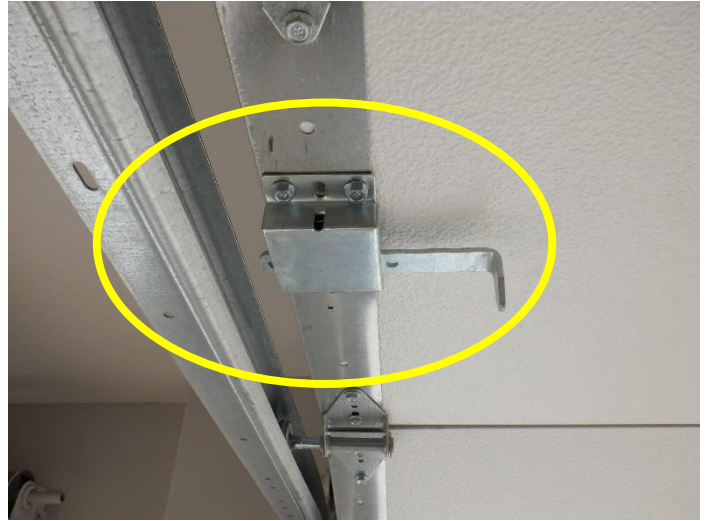
☒ ☐ ☐ ☒ **G. Garage Door Operator(s)**

- Door locks are not disabled or removed.
- Large overhead door rubs ceiling track when closing. I recommend a overhead door company further elevate and repair as required.

- Door locks are not disabled or removed.
- Large overhead door rubs ceiling track when closing. I recommend a overhead door company further elevate and repair as required.

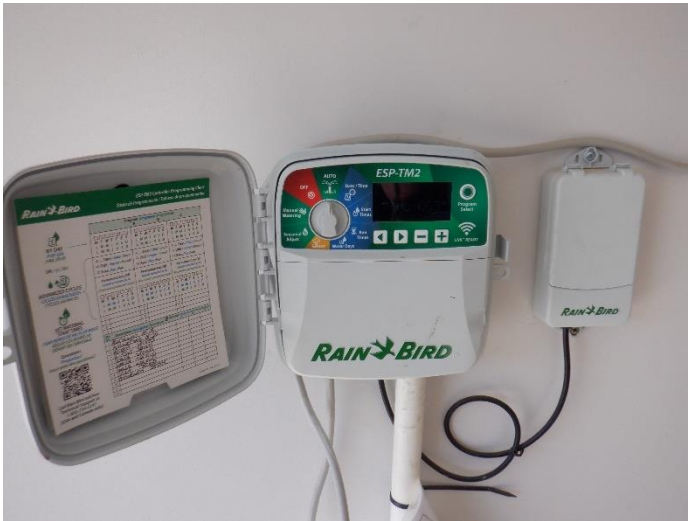
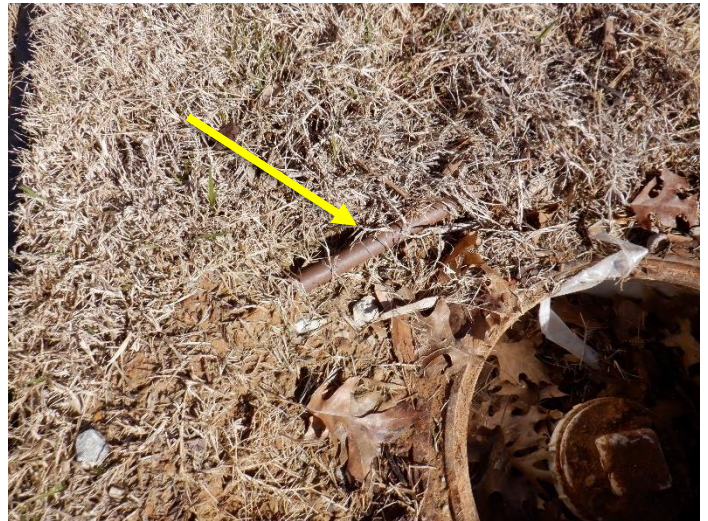
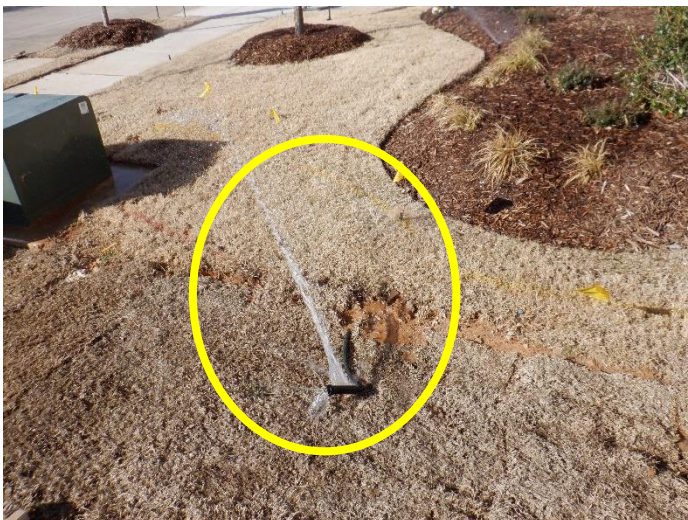
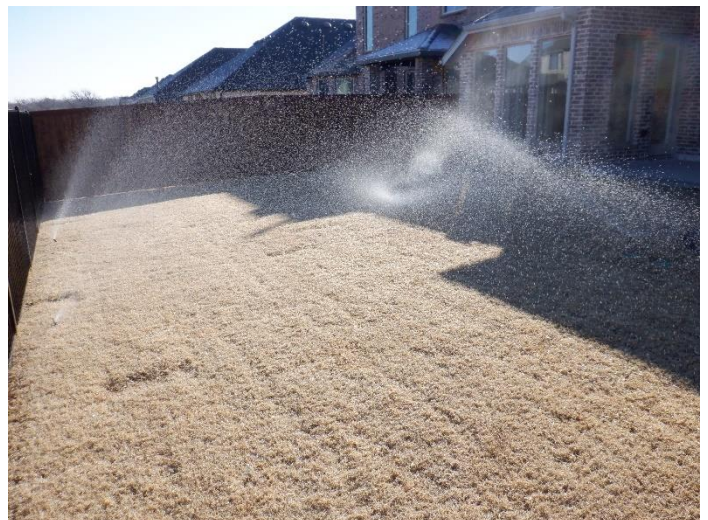
☒ ☐ ☐ ☒ A. Landscape Irrigation Sprinkler Systems

- System has one or more stations of soaker lines. These stations do not have above ground heads and are not evaluated completely.
- All soaker lines should be completely buried. Exposed lines can easily be damaged.
- One or more spray head spray onto structure.
- Station 3 has one or more broken or leaking heads.
- I recommend a Certified Sprinkler Company evaluate and repair as required.

- System has one or more stations of soaker lines. These stations do not have above ground heads and are not evaluated completely.
- All soaker lines should be completely buried. Exposed lines can easily be damaged.
- One or more spray head spray onto structure.
- Station 3 has one or more broken or leaking heads.
- I recommend a Certified Sprinkler Company evaluate and repair as required.
